Replacement of Melter 2 at the Defense Waste Processing Facility (DWPF)

Brandon Hodges

Savannah River Remediation

April 24, 2018

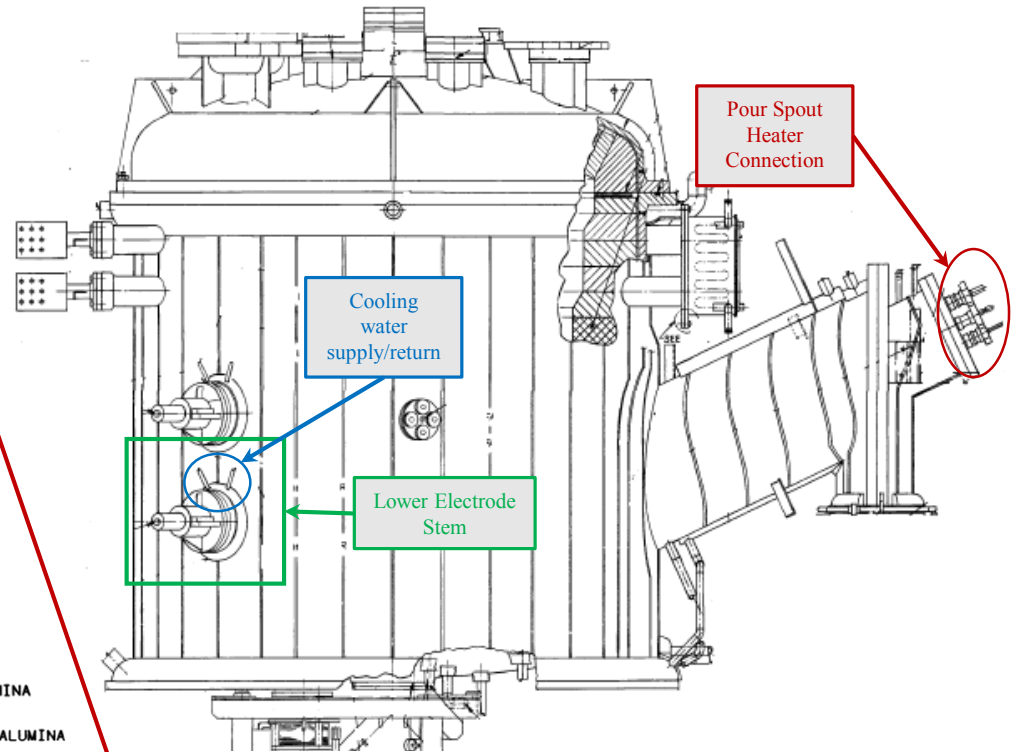
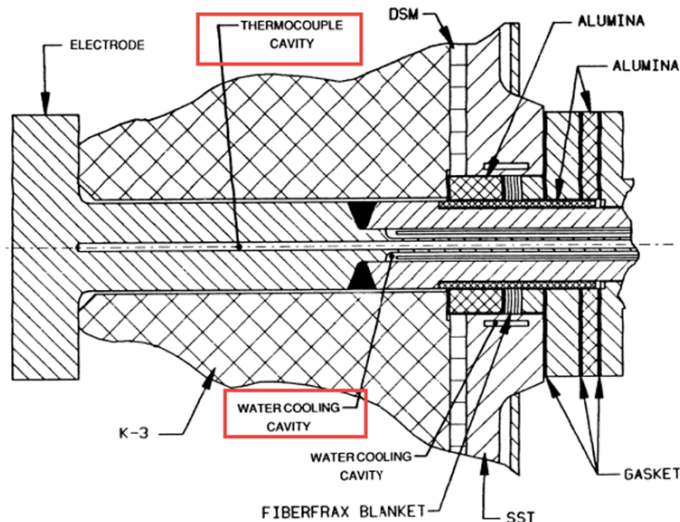
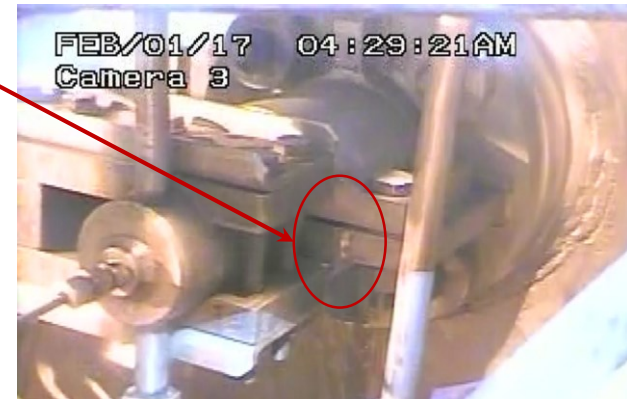
- Experienced a failure of the pour spout heater on January 26, 2017
- Experienced a failure of the lower electrodes on February 1, 2017
- Cooling water observed dripping from L4 electrode stem
- Cooling water supply could have breached electrode stem wall or thermocouple cavity
- Breach would have resulted in contact between cooling water and molten glass which would have quenched glass at the breach location

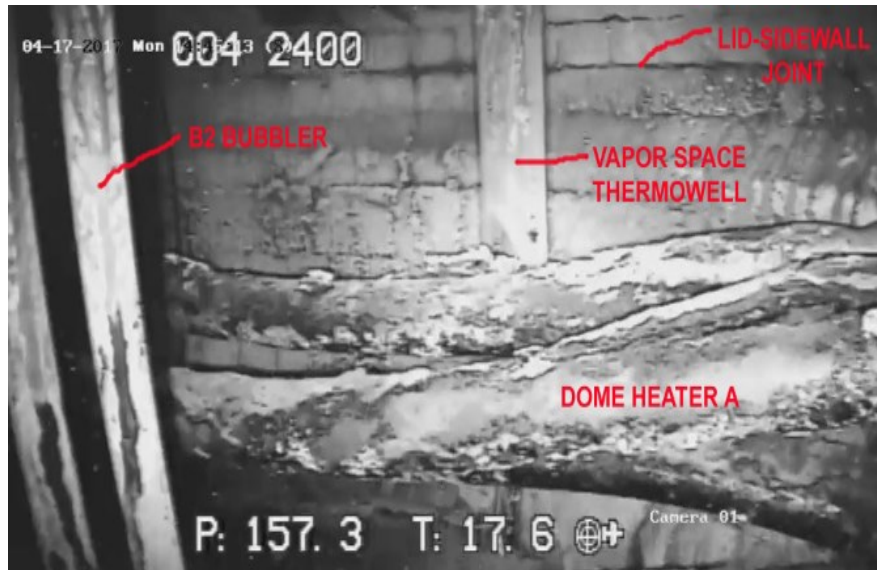
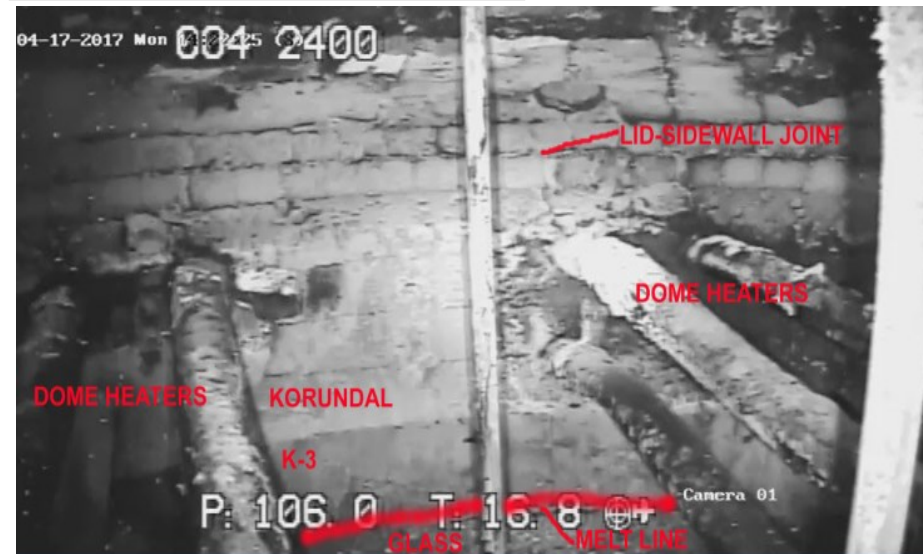
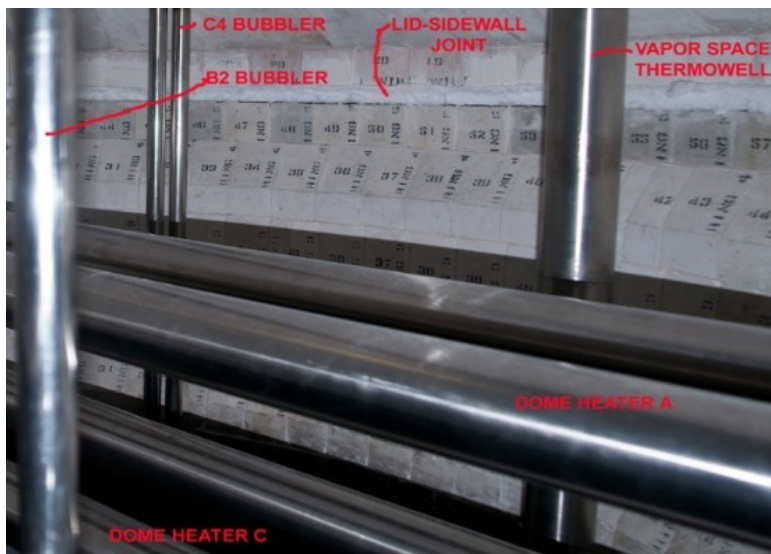
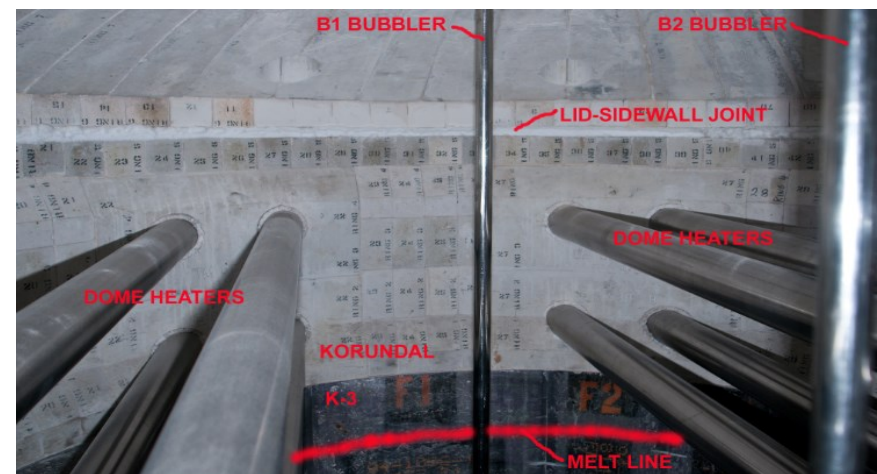
Internal Inspection of Melter 2

- Completed with the support from SRNL
 - Provided video camera system and recording equipment
- Camera was suspended from the Melt Cell in-cell crane
 - Remotely operated from a station at the Melt Cell window
- Inspection revealed that overall condition appeared significantly more degraded than Melter 1
 - Expected due to 6 additional years of operation
- Inspection did not reveal any obvious issues with Dome Heater D that would have caused its failure
- Due to the level of glass in the melter, an inspection of the L4 electrode to potentially determine the cause of failure was not possible
- Melter Engineering and SRNL evaluated the inspection video and a joint paper has been released (SRNL-STI-2017-00428)

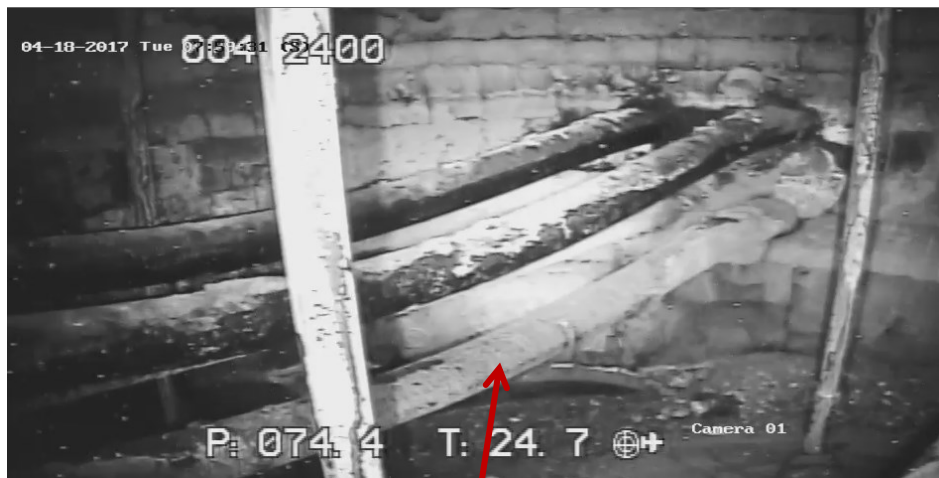
Signs of push up on ends of bars and then sagging in the middle

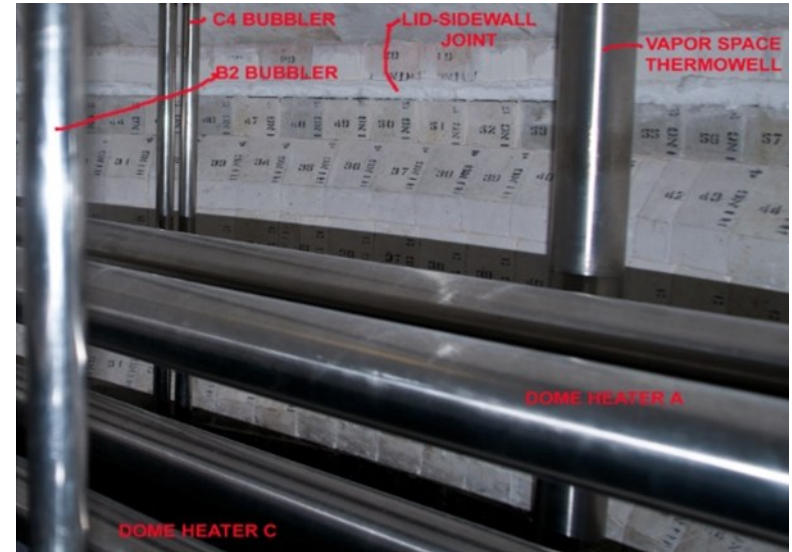
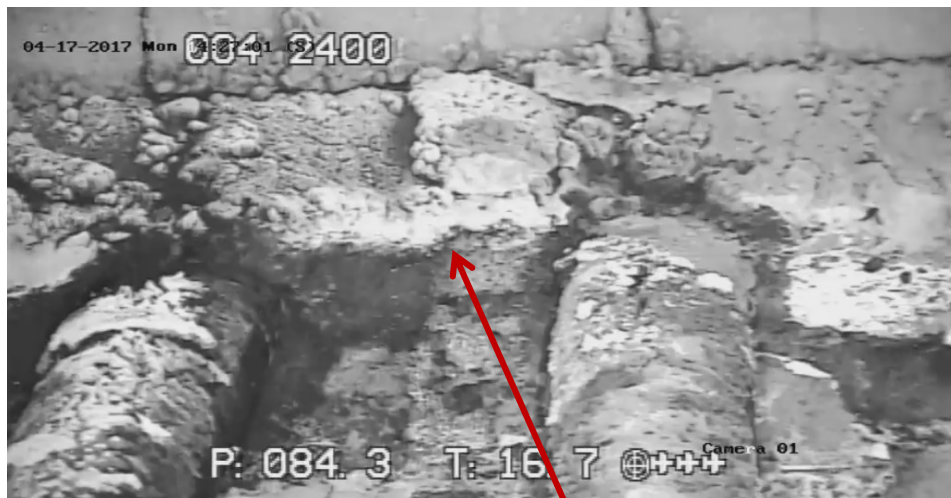
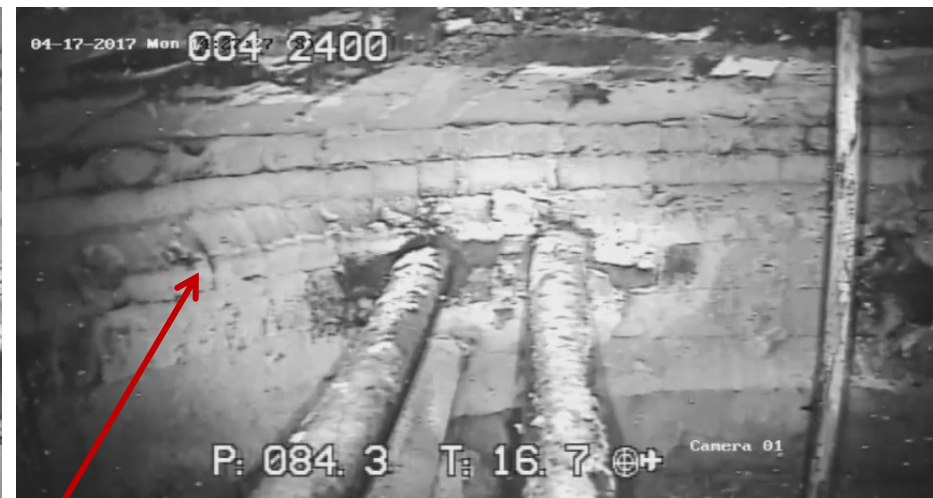
45° ledge still in tact in some areas, but missing in others

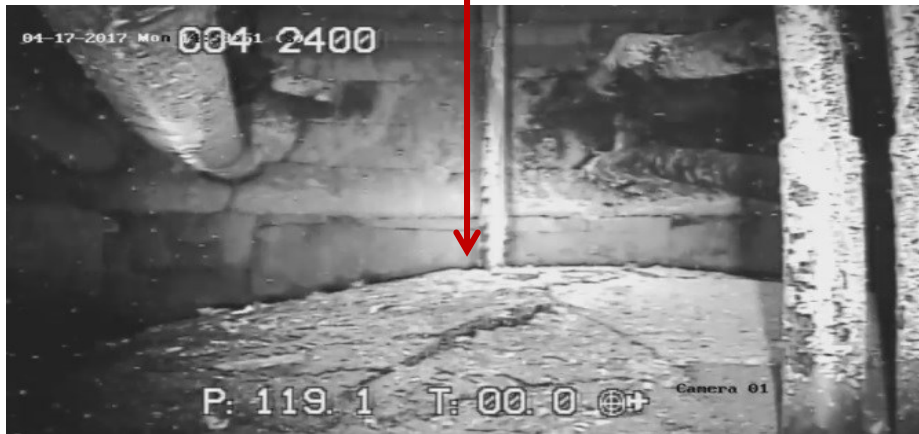
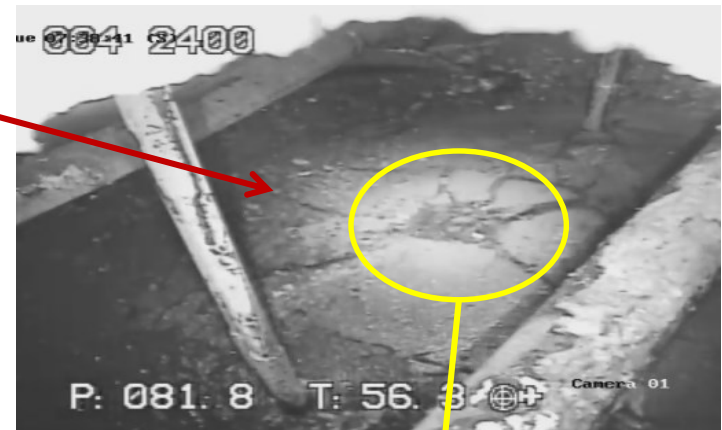
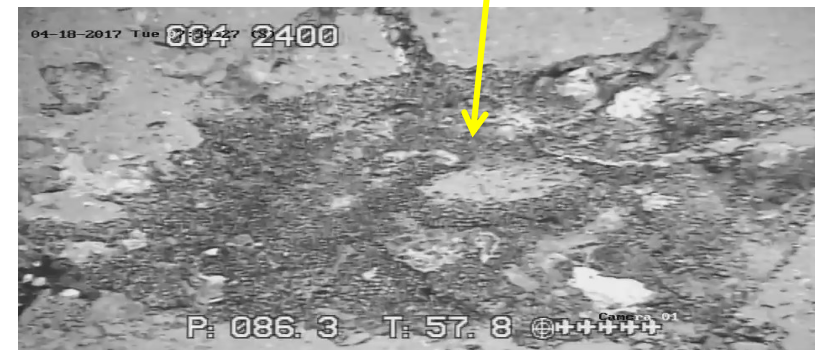
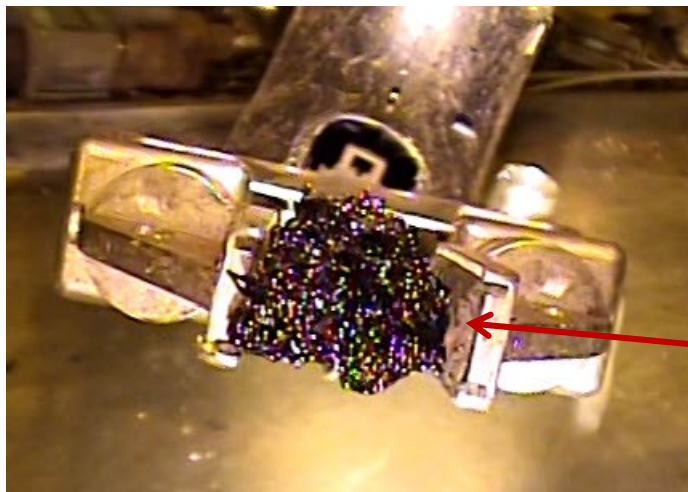
Mound in center of melter

Visual observation of the sample determined the glass was a "foamy" glass. This is likely due to the introduction of gas into the melt pool which formed a foam like layer on top of the melt pool. This layer produced the glass observed in the sample as it cooled when the melter was de-energized.

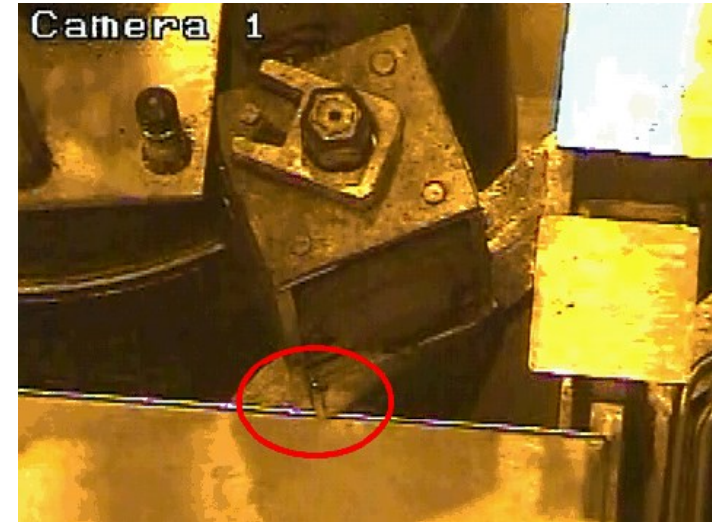
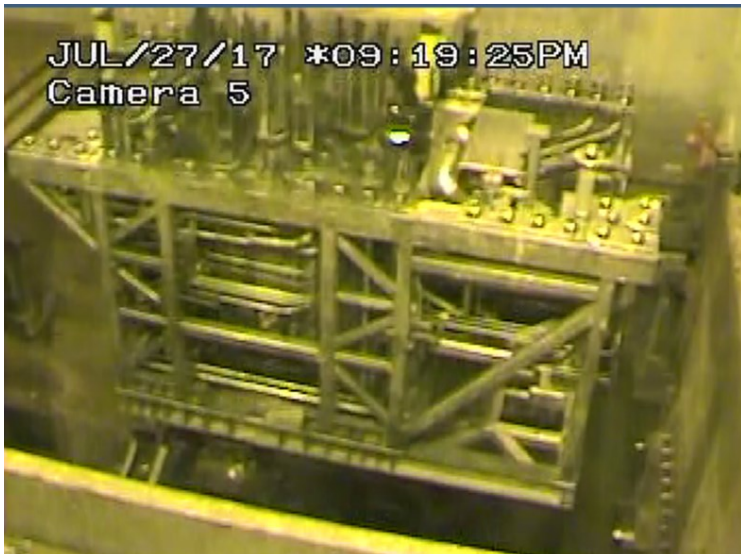
- Electrical testing was duplicated in the Outer RRW to ensure that no damage had occurred to Melter 3 during loading and transport to the DWPF
- Remote fit-up test of seal pot on Melter 3
 - Done based on lesson learned from Melter 2 installation
 - Only 1 seal pot is available so fit-up prior to transport to RRW was not possible
 - Interference discovered between the Melter Dome Heater splash guard and the seal pot drain valve actuator
